Third Five-Year Review Report
for
Raymark Industries, Inc. Site
Stratford, Connecticut

September 2010

The United States Environmental Protection Agency
Region 1, New England
Boston, Massachusetts

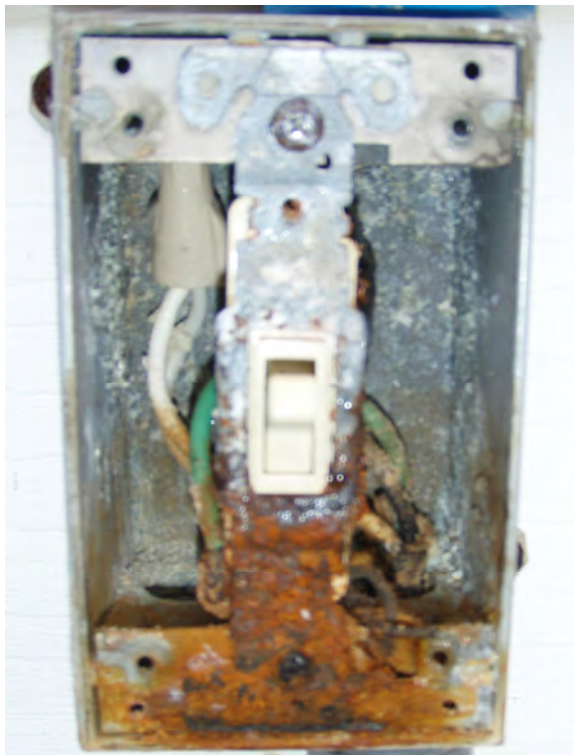
Photograph 1) House #3 – 29 Burr Place: Electric Box

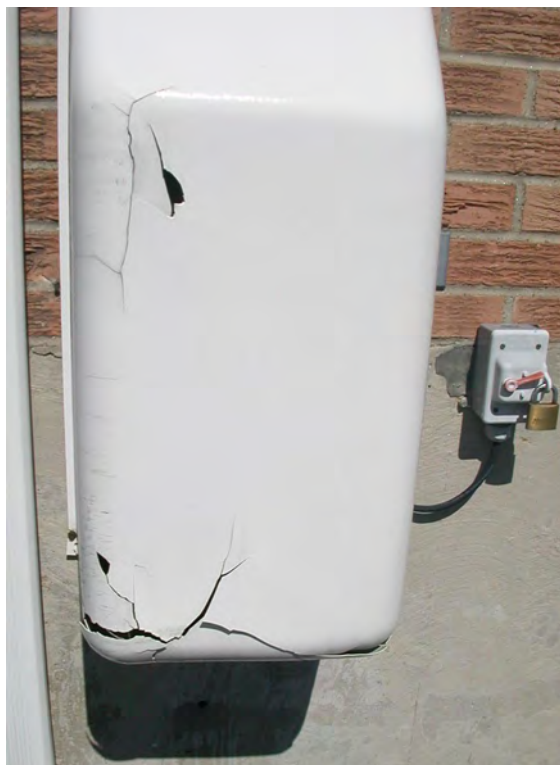
Photograph 2) House #7 – 450 Ferry Boulevard: Cover

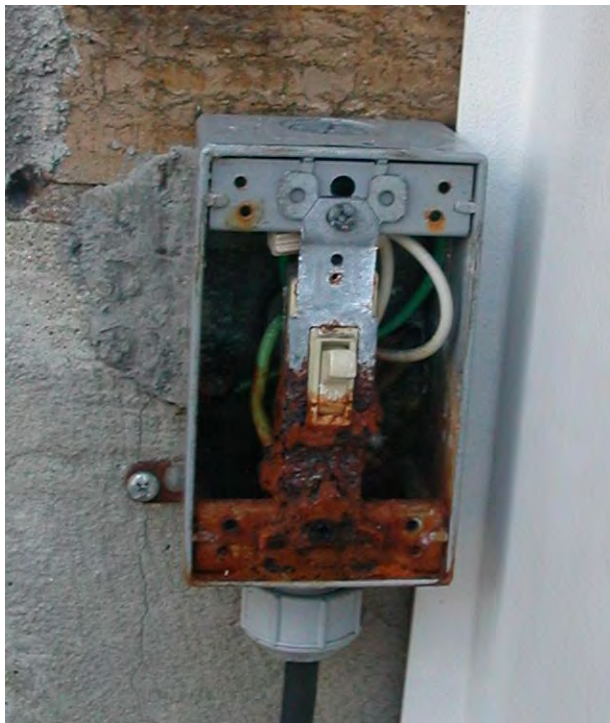
Photograph 3) House #8 – 470 Ferry Boulevard: Electric Box

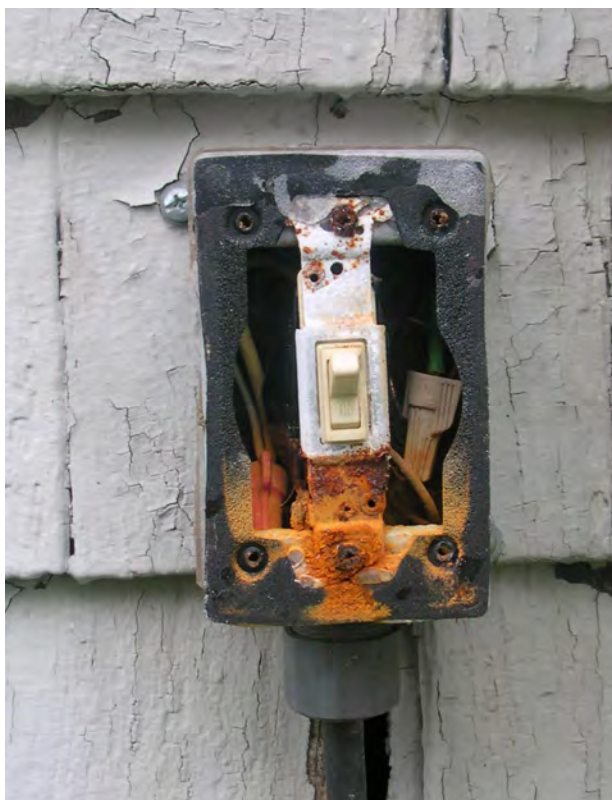
Photograph 4) House #13 – 36 Homestead Avenue: Electric Box

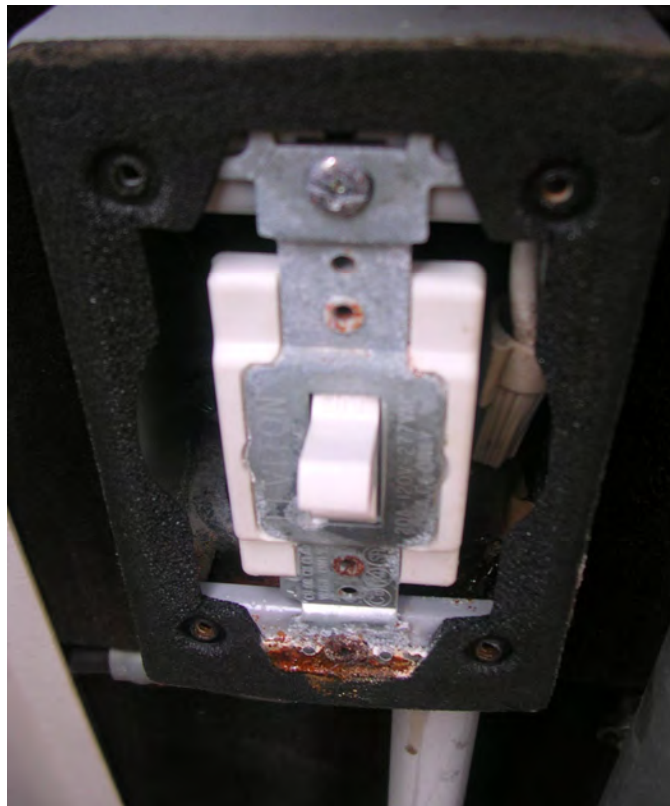
Photograph 5) House #15 – 63 Homestead Avenue: Electric Box

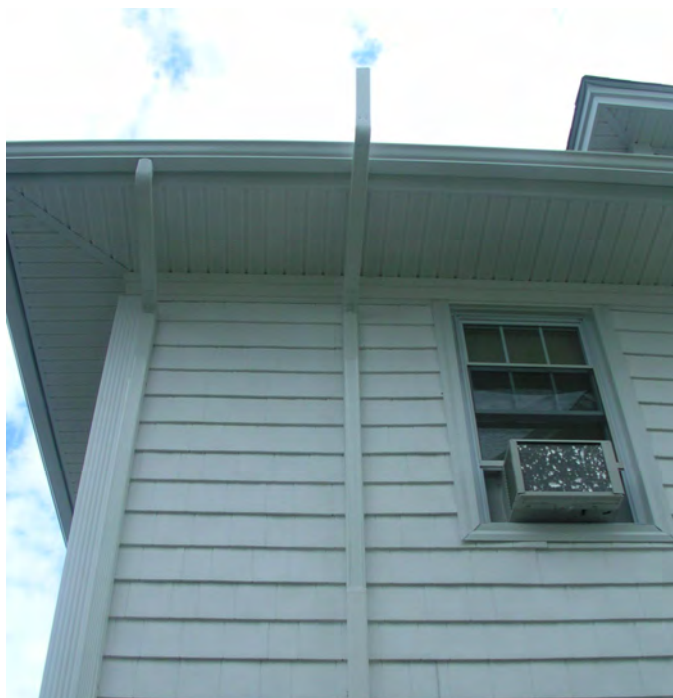
Photograph 6) House #19 – 79 Homestead Avenue: Vent Cap

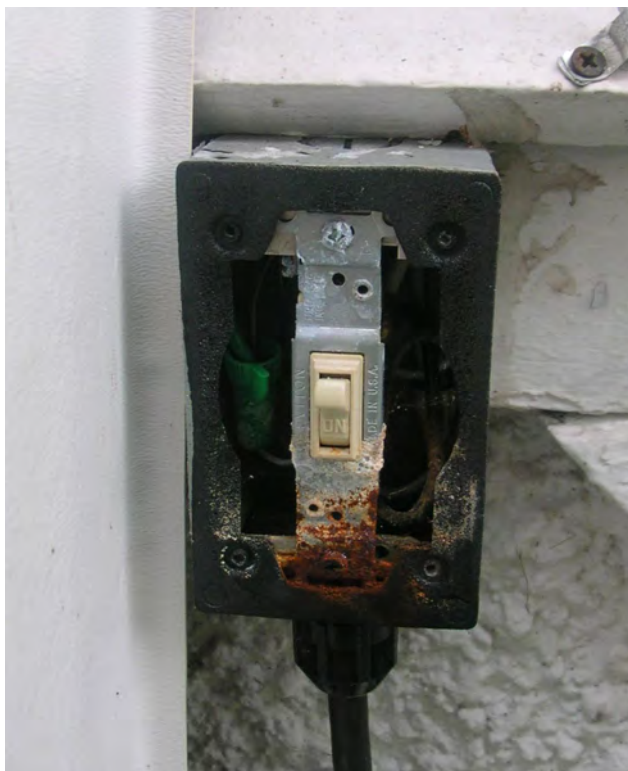
Photograph 7) House #19 – 79 Homestead Avenue: Electric Box

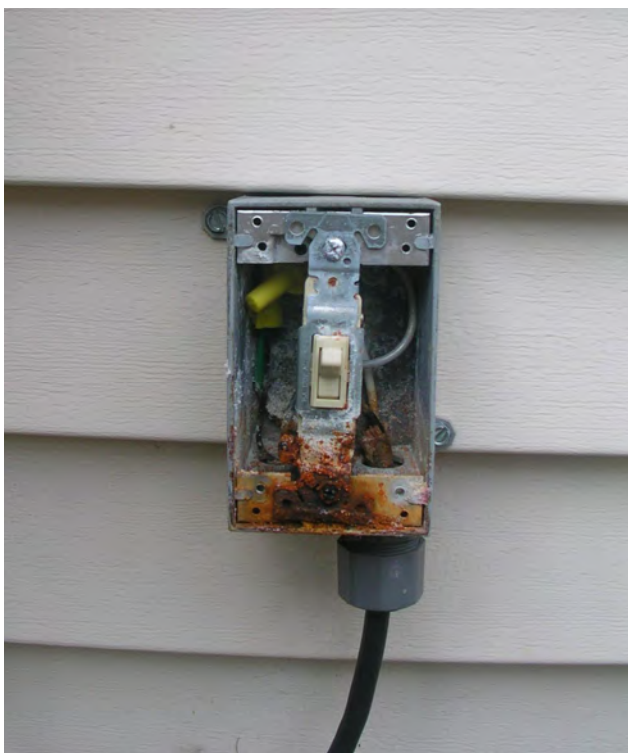
Photograph 8) House #20 – 85 Homestead Avenue: Electric Box

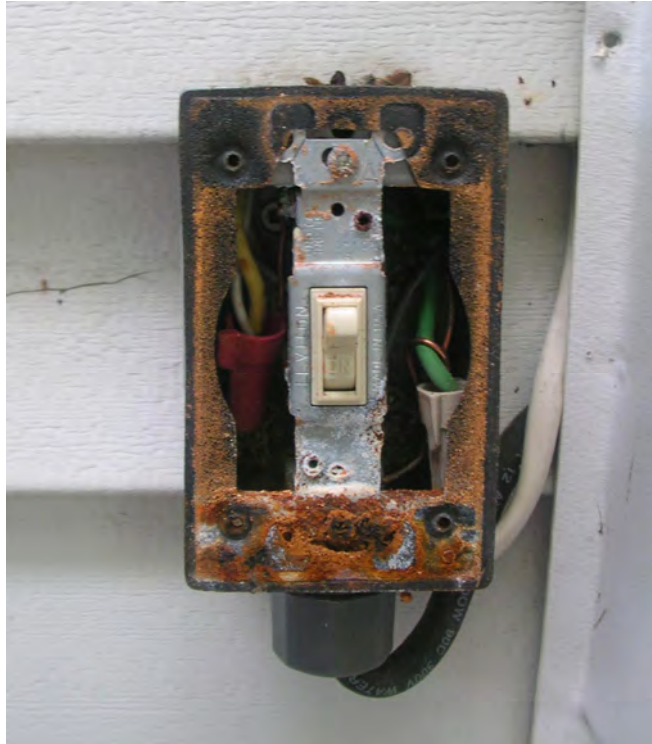
Photograph 9) House #24 – 109 Homestead Avenue: Electric Box

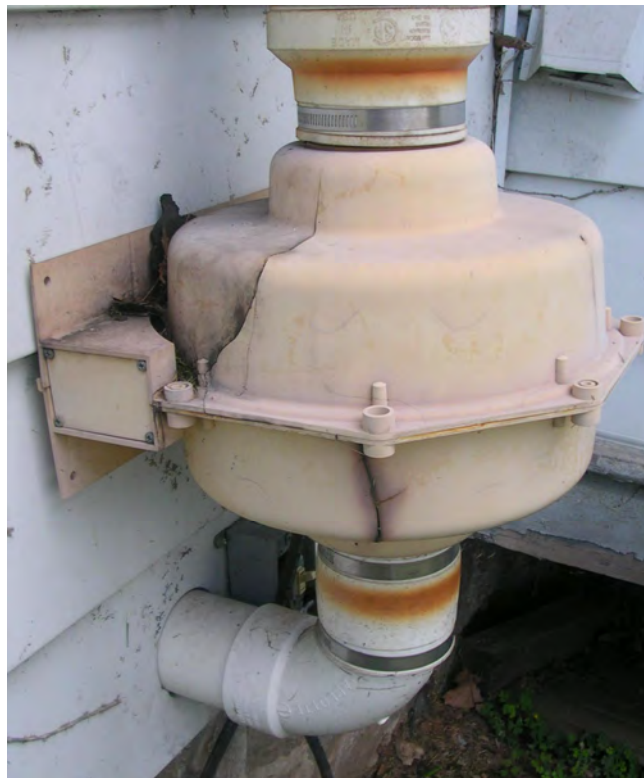
Photograph 10) House #25 – 125 Homestead Avenue: Fan Casing

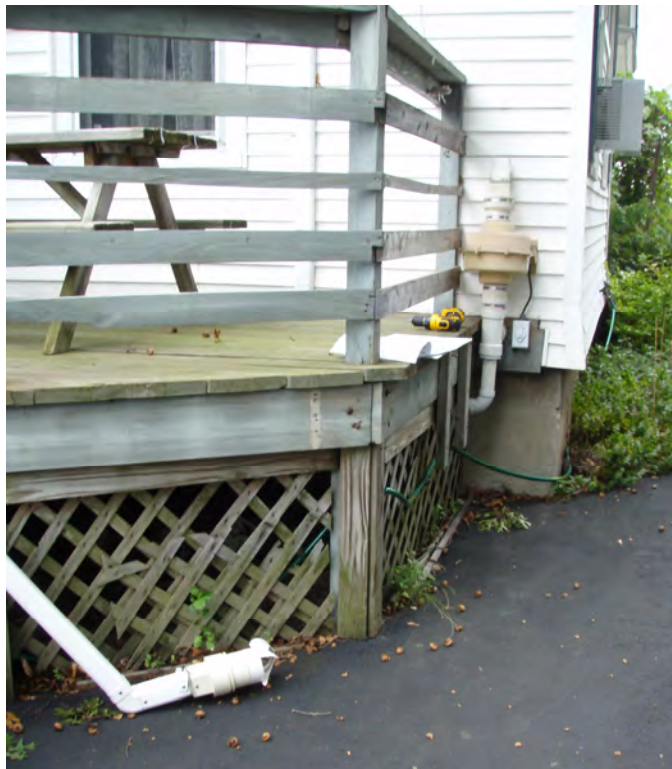
Photograph 11) House #26 – 231 Housatonic Avenue: Vent Pipe and Cap

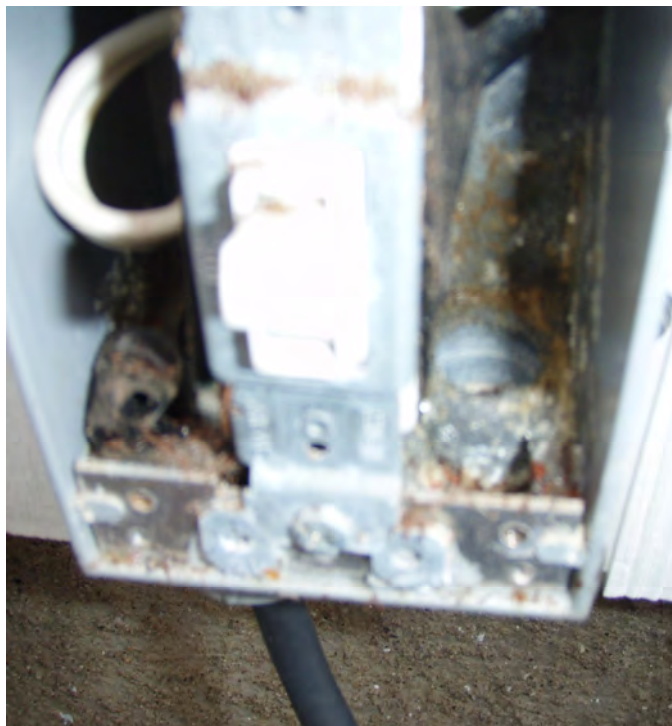
Photograph 12) House #27 – 232 Housatonic Avenue: Electric Box

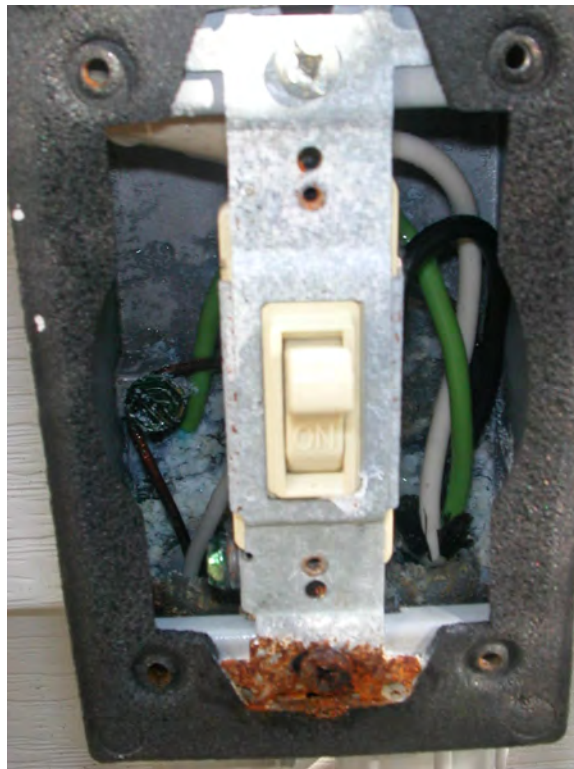
Photograph 15) House #62 – 560 Housatonic Avenue: Electric Box

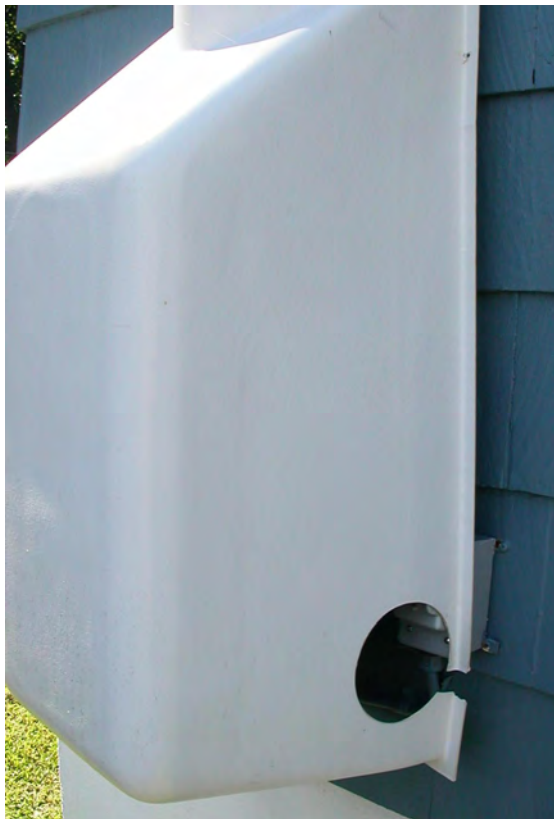
Photograph 17) House #69 – 76 Minor Avenue: Cover

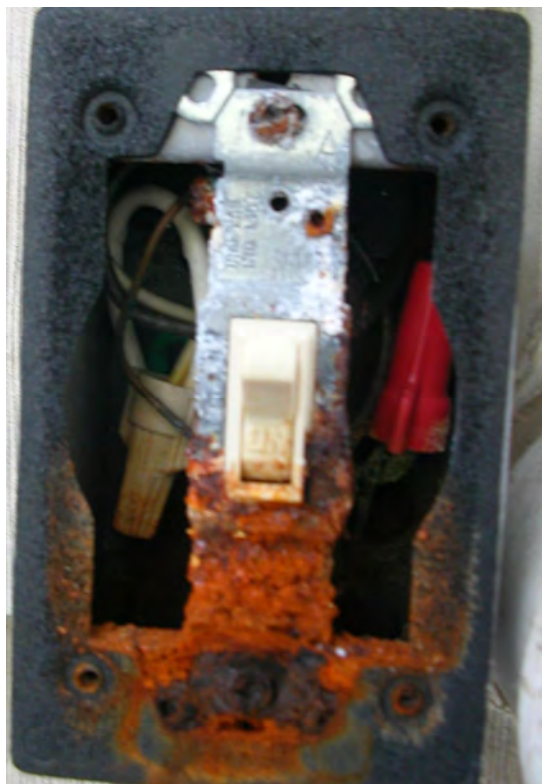
Photograph 19) House #86 – 135 Riverview: Electric Box

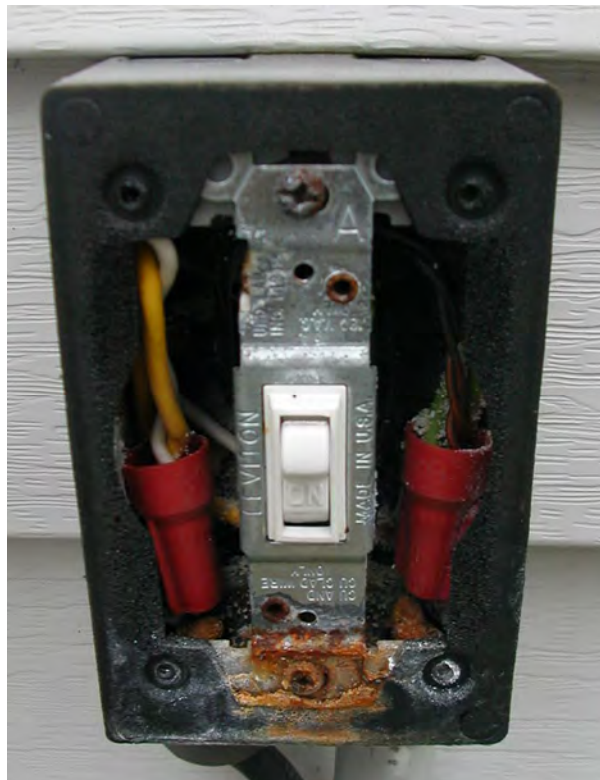
Photograph 21) House #93 – 73 Willow Avenue: Electric Box

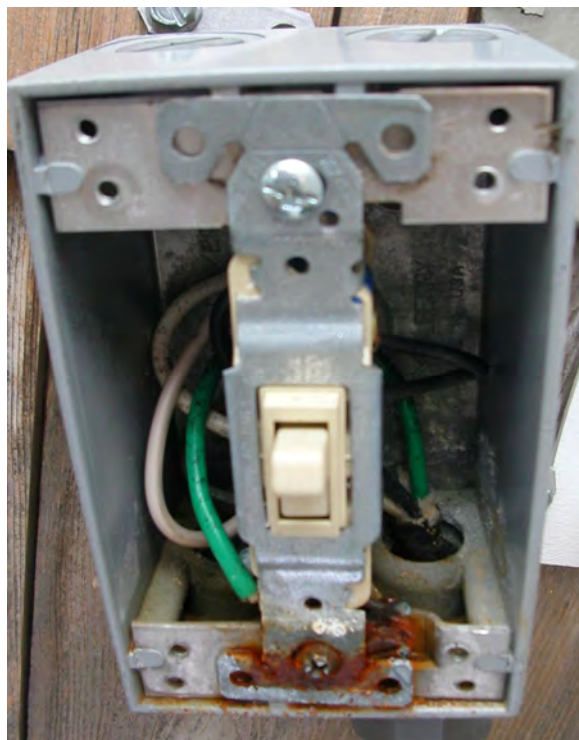
Photograph 22) House #94 – 86 Willow Avenue: Electric Box

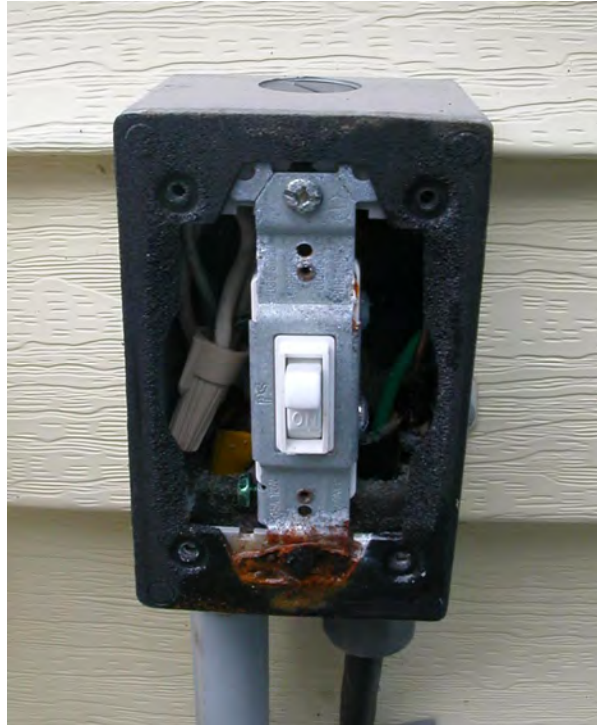
Photograph 23) House #95 – 93 Willow Avenue: Electric Box

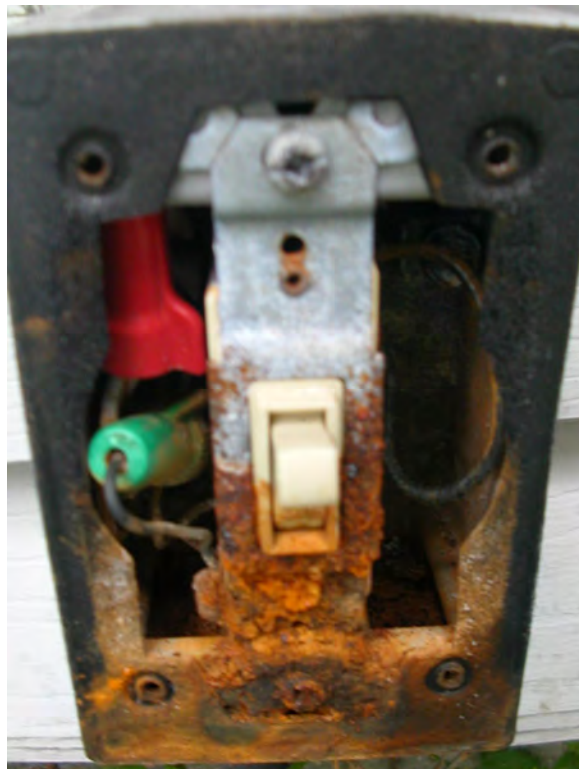
Photograph 24) House #100 – 116 Willow Avenue: Electric Box

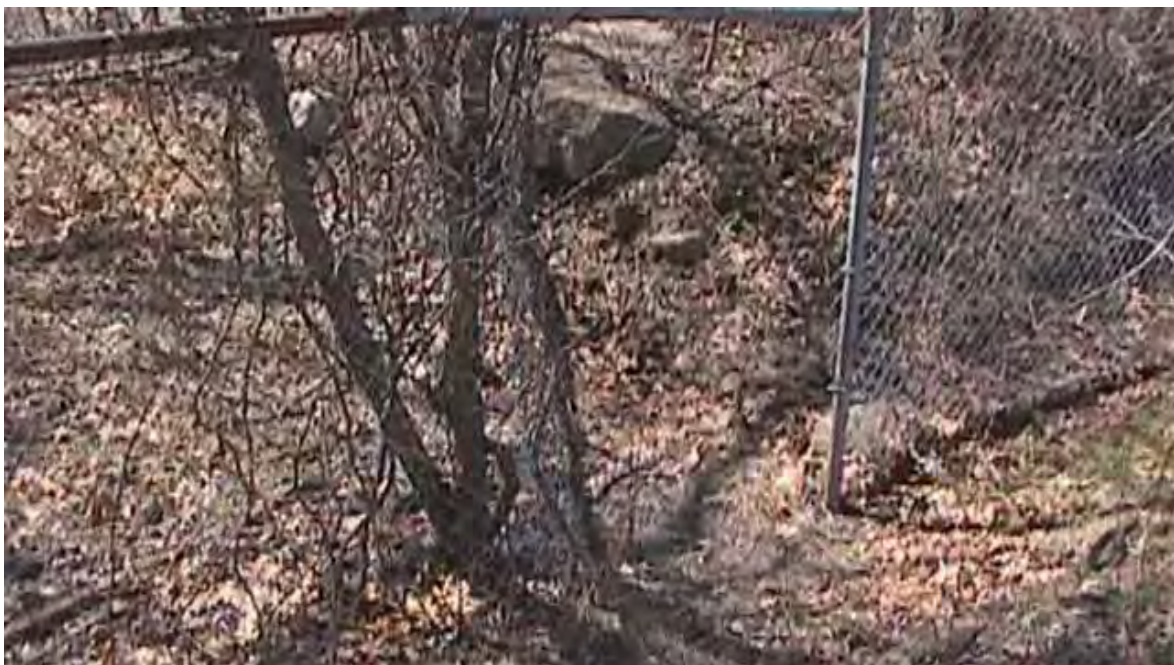
Break in Fence between Contract Plating and OU4.

8. More security on-site is needed to stop vandalism.

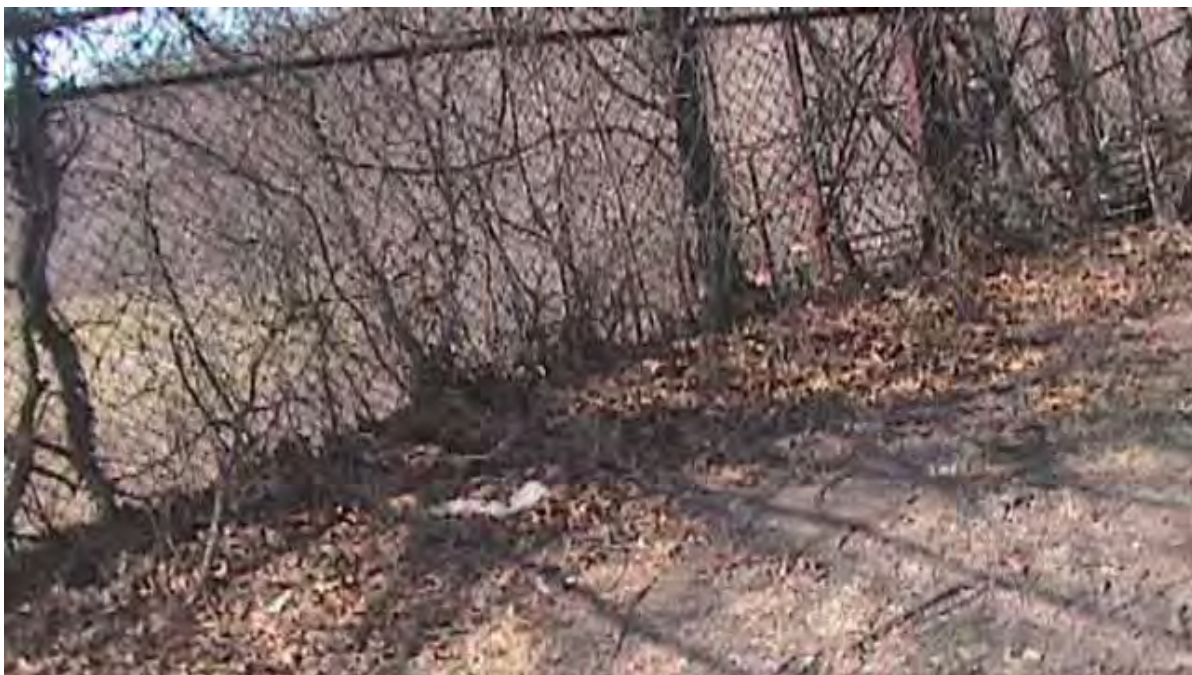
Neighboring the corner of Patterson and Frog Pond. Bleachers visible in background. Please note the lack of signage on fence.

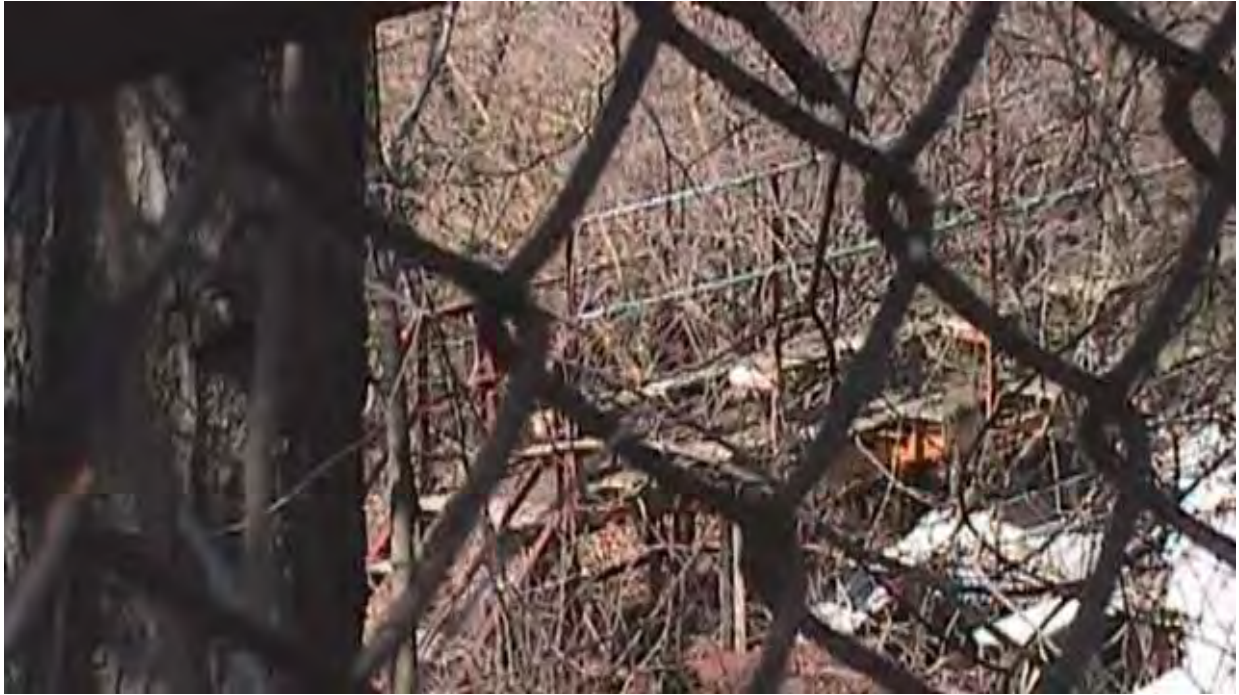
Overgrown bleacher area.

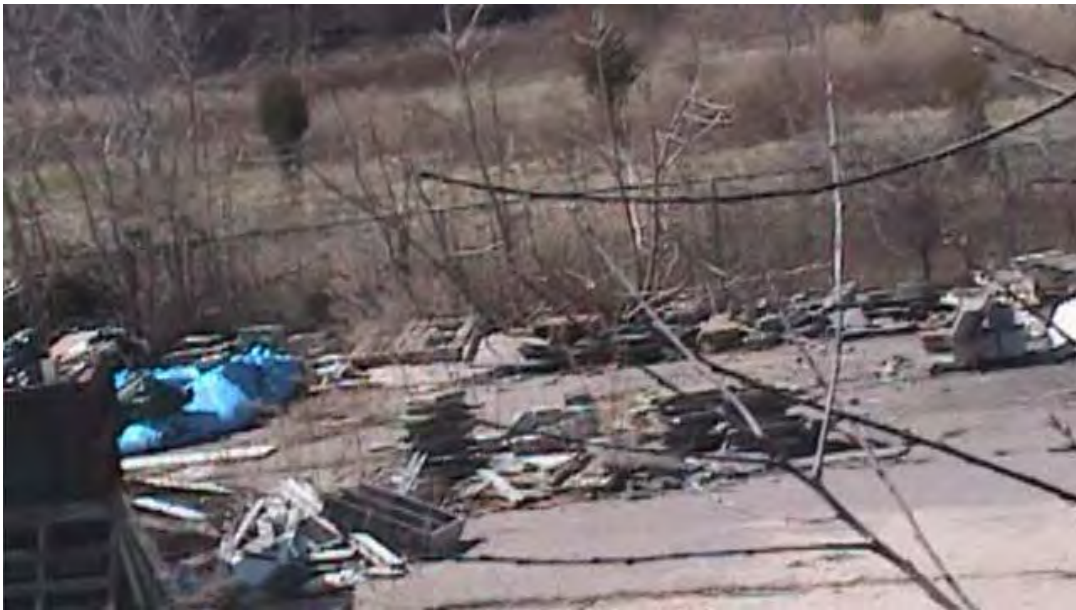
Trash in storage pad.

6. Property owner(s) should be informed that on-site dumping of construction or other materials should cease.
7. Attention is needed to address animals burrowing through the cover material into waste.

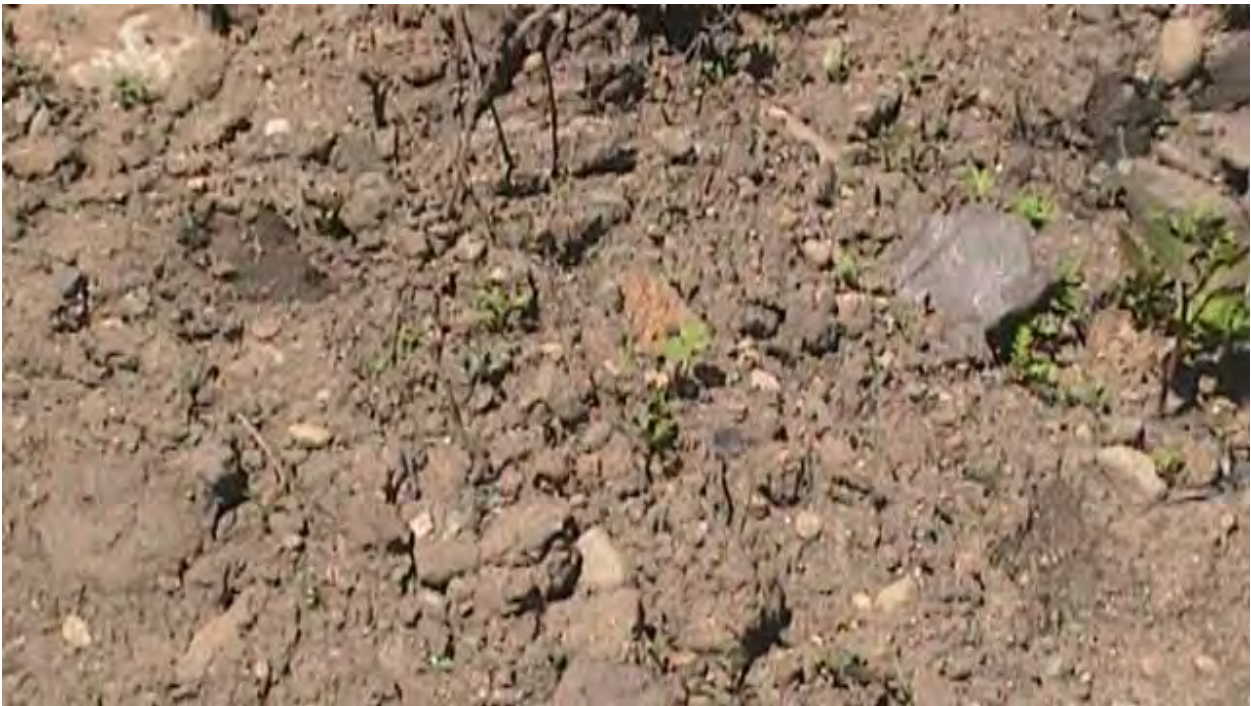
In 2009, 340 East Main Street required emergency response due to the unauthorized excavation of Raymark waste. The property owner excavated Raymark waste that was buried on the property and spread the Raymark waste on the surface of the property. CTDEP responded to the site on May 18, 2009 to evaluate the conditions at the property and on May 19, covered the excavated material with a membrane and clean fill. On May 20, 2009, EPA Emergency Response arrived on-site to secure additional areas where Raymark waste was placed and to decontaminate mechanical equipment used during the unauthorized excavation. The State of Connecticut filed suit for cost recovery of CTDEP's expenditure and a final injunction prohibits any future activity that could release Raymark waste.

Raymark waste disturbed by on-site activities.

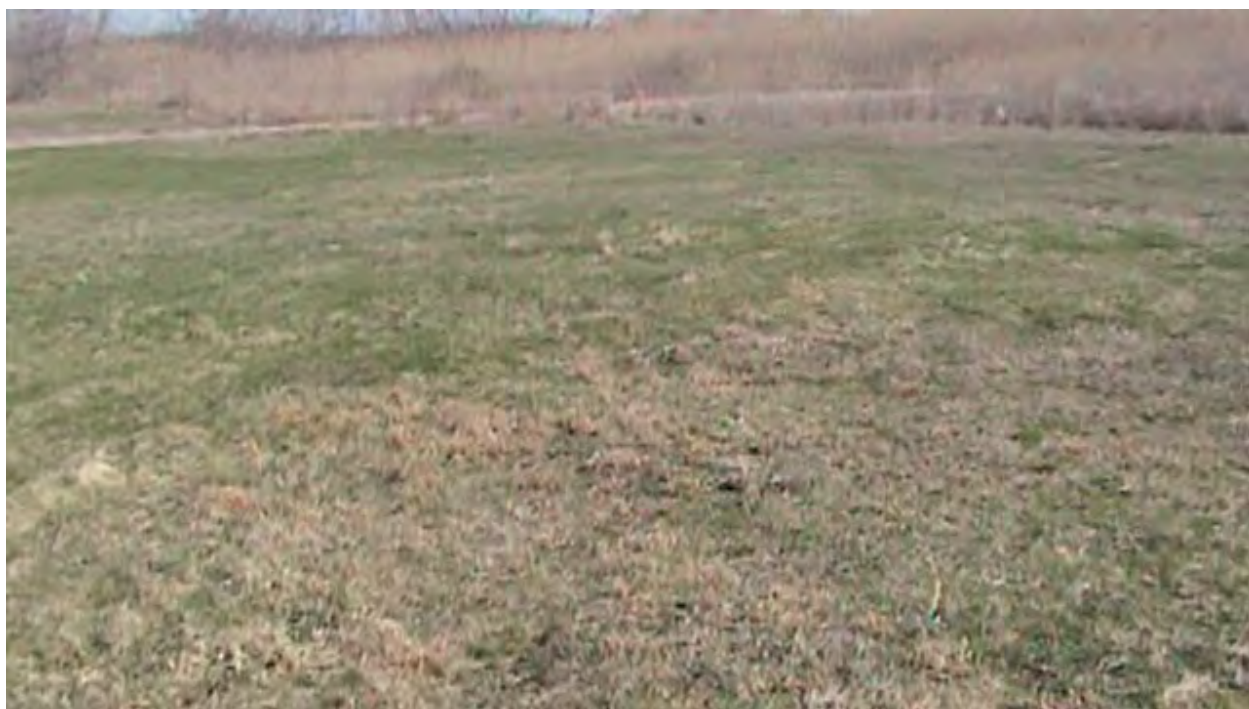
Area of Raymark waste near drainage stream.

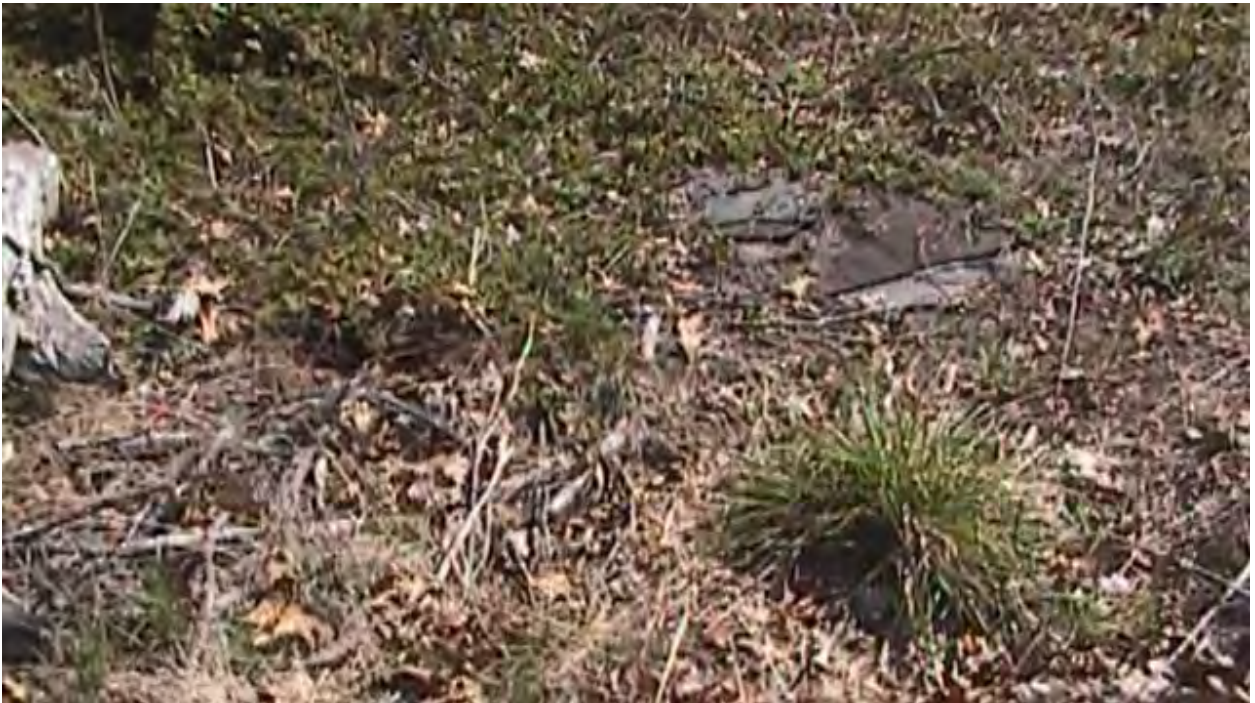
Waste dumping evidence.

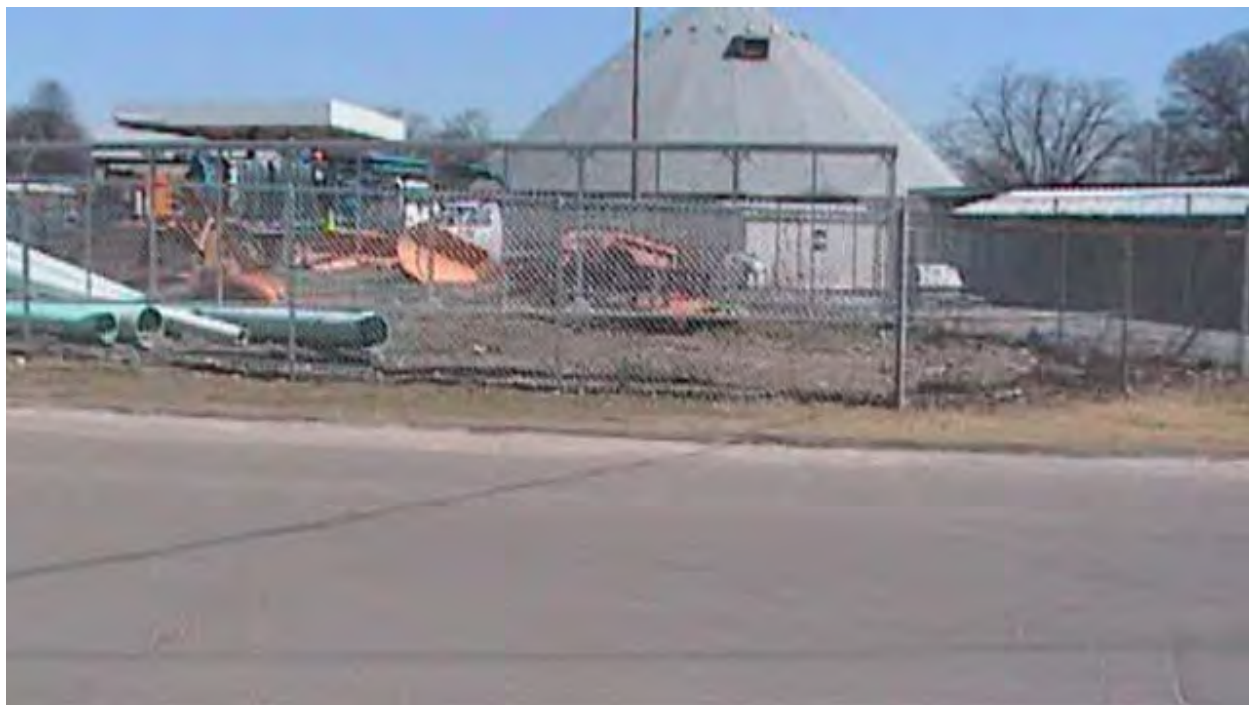
Area where Raymark waste was identified near dog pound.
